# 网卡固件升级工具用户手册

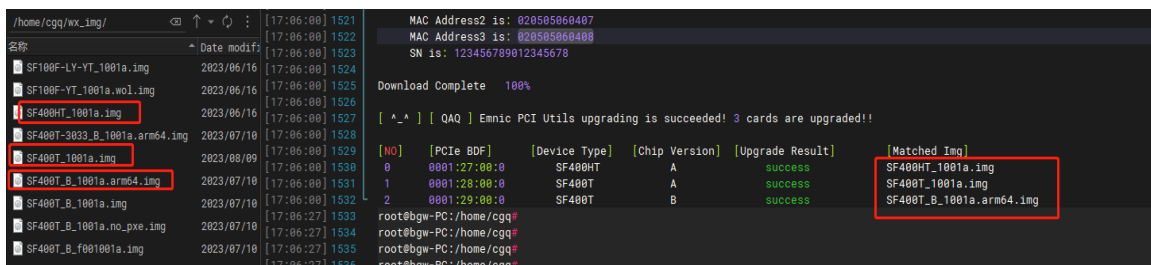
a) wx\_img 目录下均有与网卡匹配的固件，烧录成功结果如下

该命令会对机器上所有网迅千兆卡的固件分析四元组（vendor ID、device ID、Sub vendor ID、Subsystem ID），pxe 类型（arm64,arm64/x86,no\_pxe,三合一），A/B 版本，随后会从 wx\_img 目录中选取与之匹配的固件进行多张卡烧录，烧录结果可在当前目录中生成的 log 文件查看

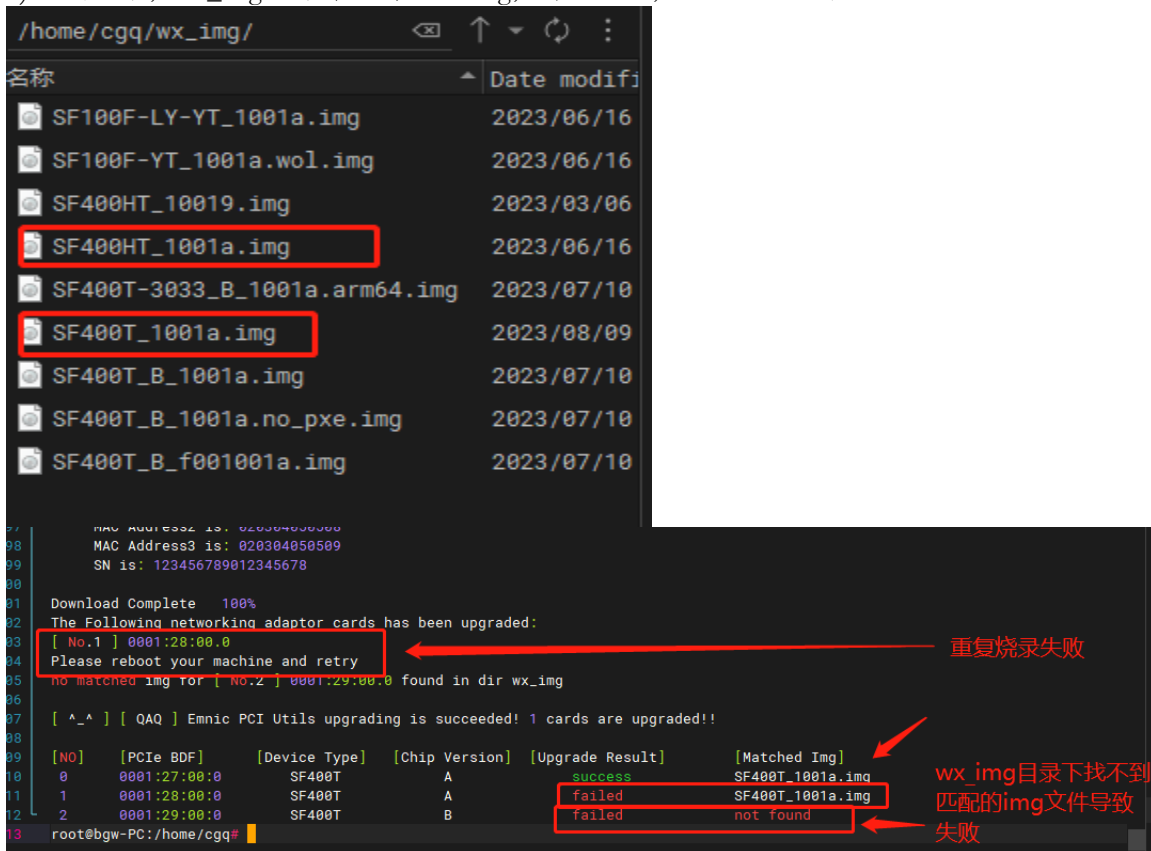
b) 重复烧录，wx\_img 目录中没有对应 img，都会报错，报错信息如下

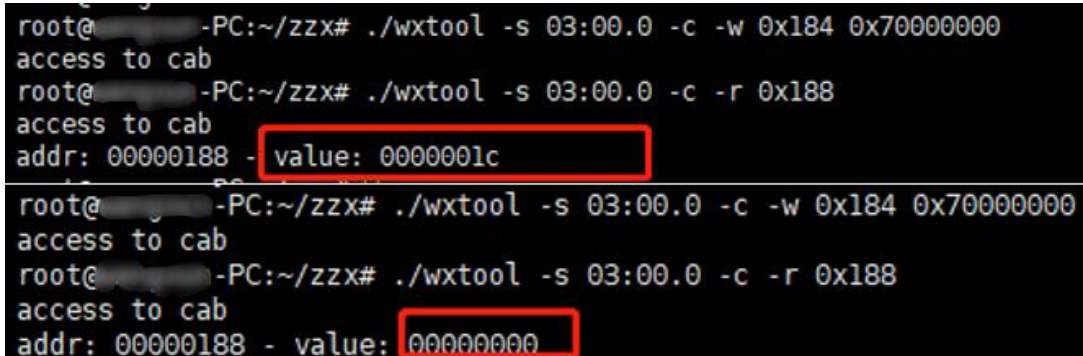
```
./wxtool -s 84:00.0 -c -w 0x184 0x70000000  
./wxtool -s 84:00.0 -c -r 0x188
```

如图，value 值若为 0000001c，则表示此时为加锁状态；value 值若为 00000000，则表示此时为解锁状态。

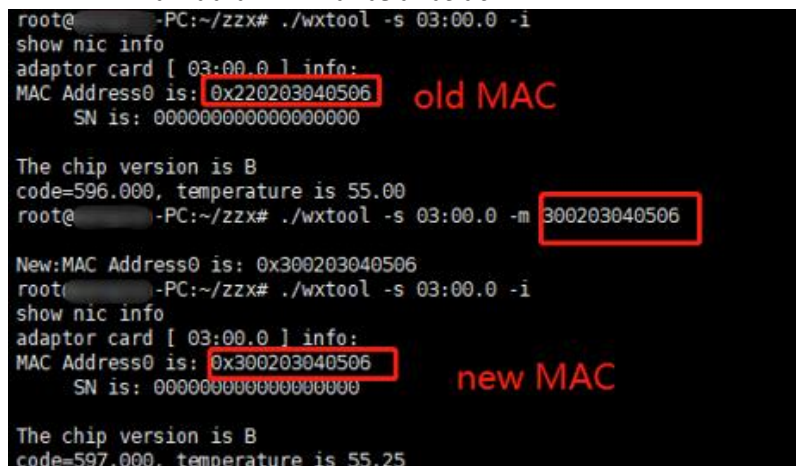
### 2.4.3 【-s -m】：修改网口 MAC 地址

命令:./wxtool -s 02:00.0 -m 220203040506
